**ANNUAL REPORT - 2023**  
**BY THE**  
**DG COMMUNICATION**  
**CENTRE ON THE**  
**INCIDENTS REPORTED**

**The Directorate General of Shipping,  
Ministry of Ports, Shipping & Waterways,  
Government of India.**

## **Marine Accidents Statistics and Report**

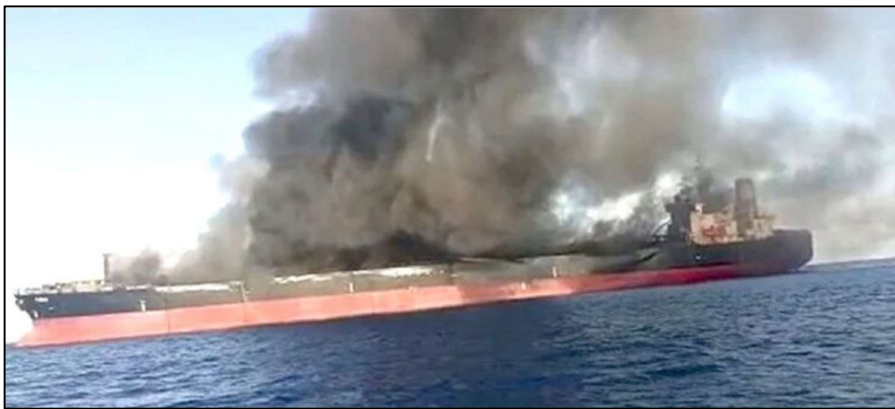
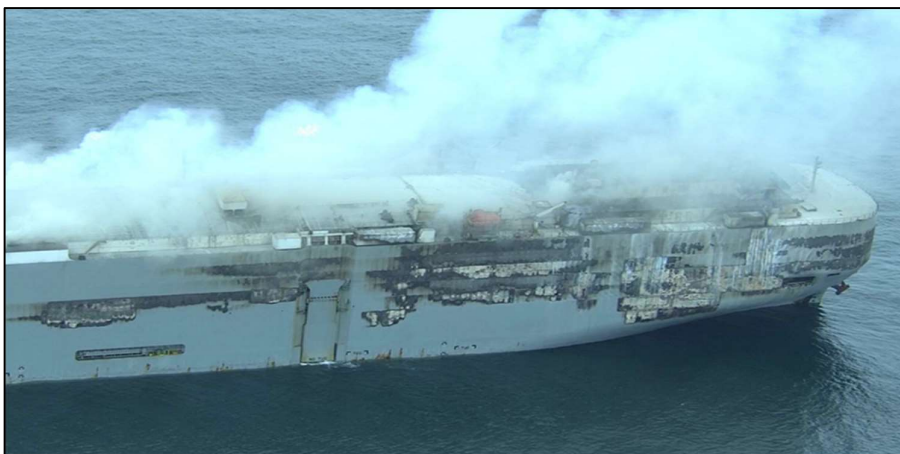
*Figure 1: Fire and explosion on tanker in Malaysian waters and fire on a car carrier in North Sea*
